Deformation Analysis of Harbour and Dam Infrastructure using Marine GIS

U.S. Hydro 2015

Mathieu Rondeau¹, Camille Stoeffler¹, Davis Brodie² and Matt Holland²

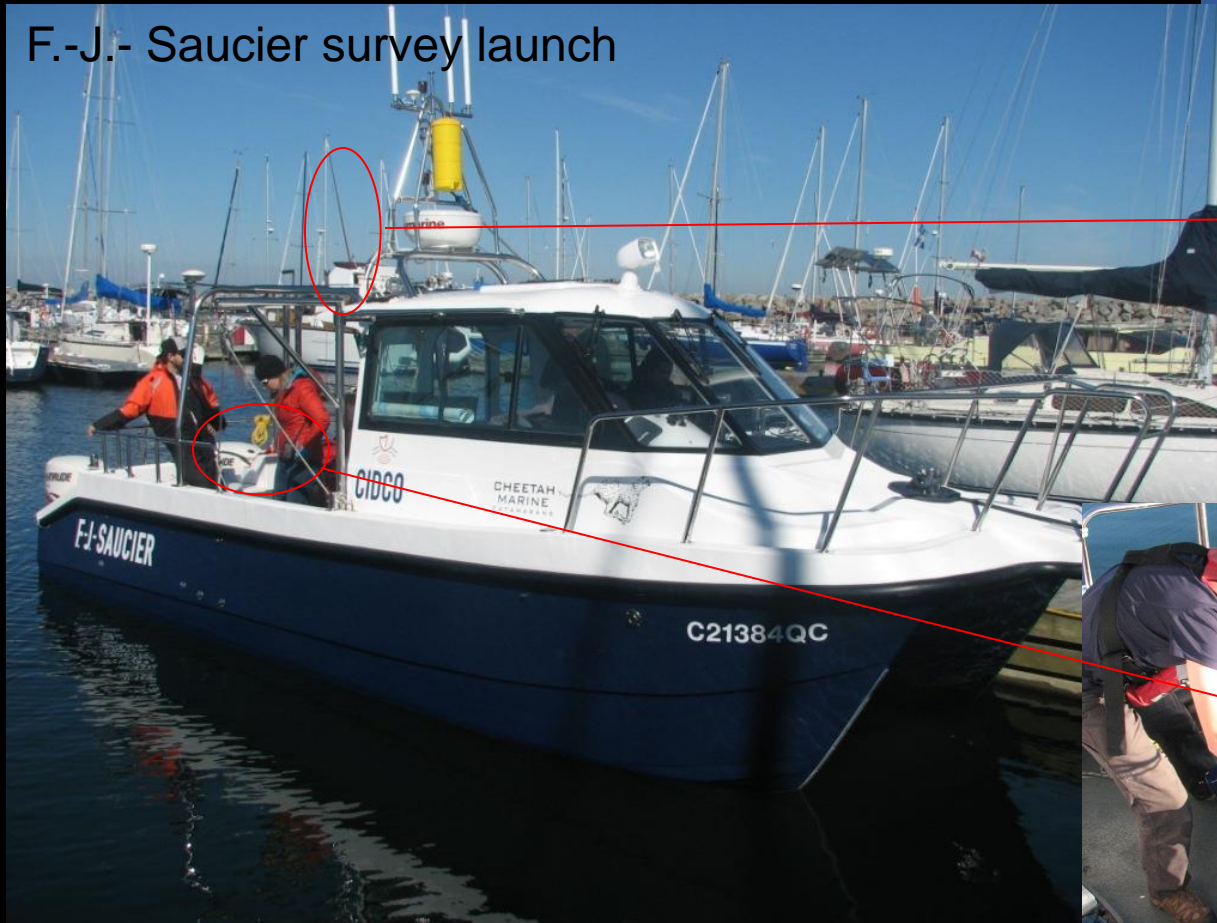
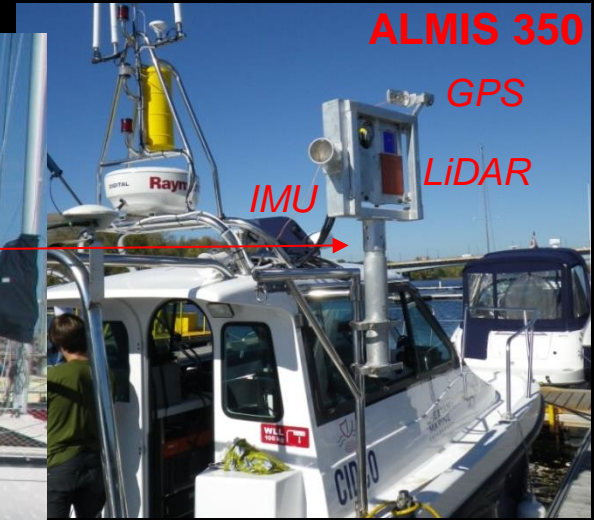
Hybridised MBES/LiDAR capture solution 2010->2012

F.-J.- Saucier survey launch

Teledyne Reson SeaBat 7125 SV2

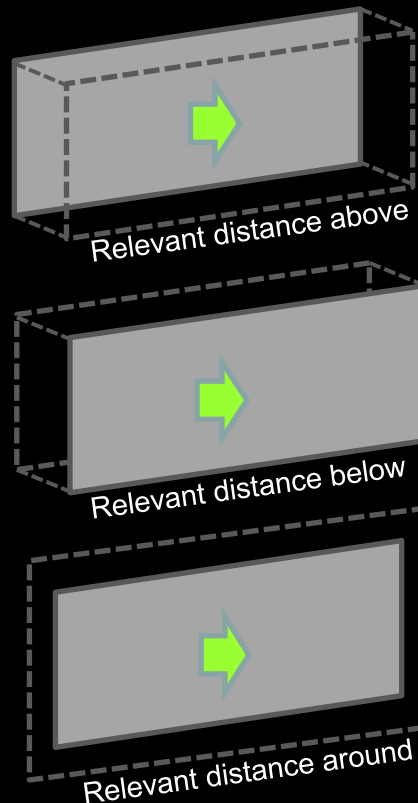
Define contributing
soundings
